### METAL ROOF/INTERNAL GUTTER (dwg. 09)

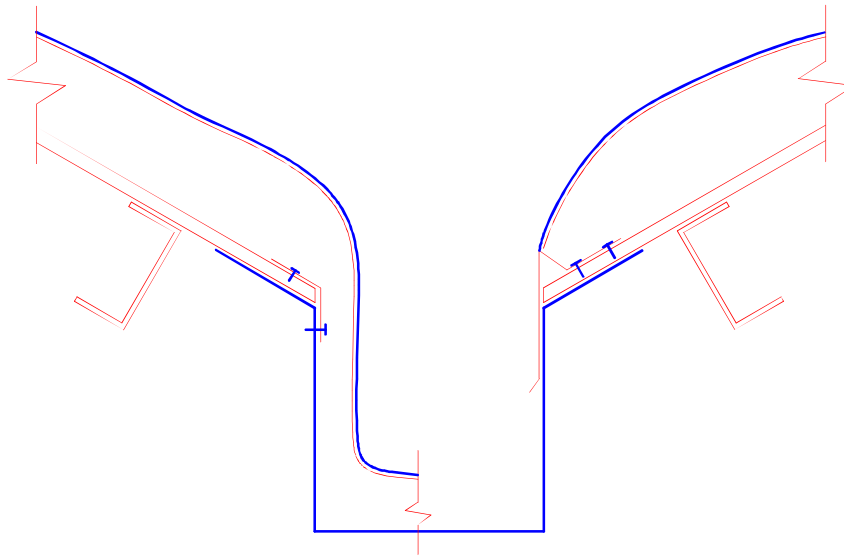
1. INTERNAL GUTTER
2. CORRUGATED METAL ROOF PANELS
3. STRUCTURAL MEMBER
4. ROOF PANEL TRIMMED FLUSH AT GUTTER 'L' METAL INSTALLED WHEN
5. PRO-TECH COATING (EC-100)
6. INSTALL 'Z' COUNTERFLASHING IF POLYURETHANE AND PROTECTIVE COATING CANNOT BE APPLIED UNDER SKYLIGHT FRAME

NOTE: CURB MAY BE METAL (OPTIONAL, VENTS)
