<b>REPAIR DETAIL (dwg. 39)</b>	DRAWN BY:	DRAWN BY:	APPROVED:
	3003 NORTH 73RD STREET, SCOTTSDALE, AZ 85251 402 EAST GRAND ROAD, TUCSON, AZ 85705	SCALE:	PROJECT NO:	DRAWING NO:

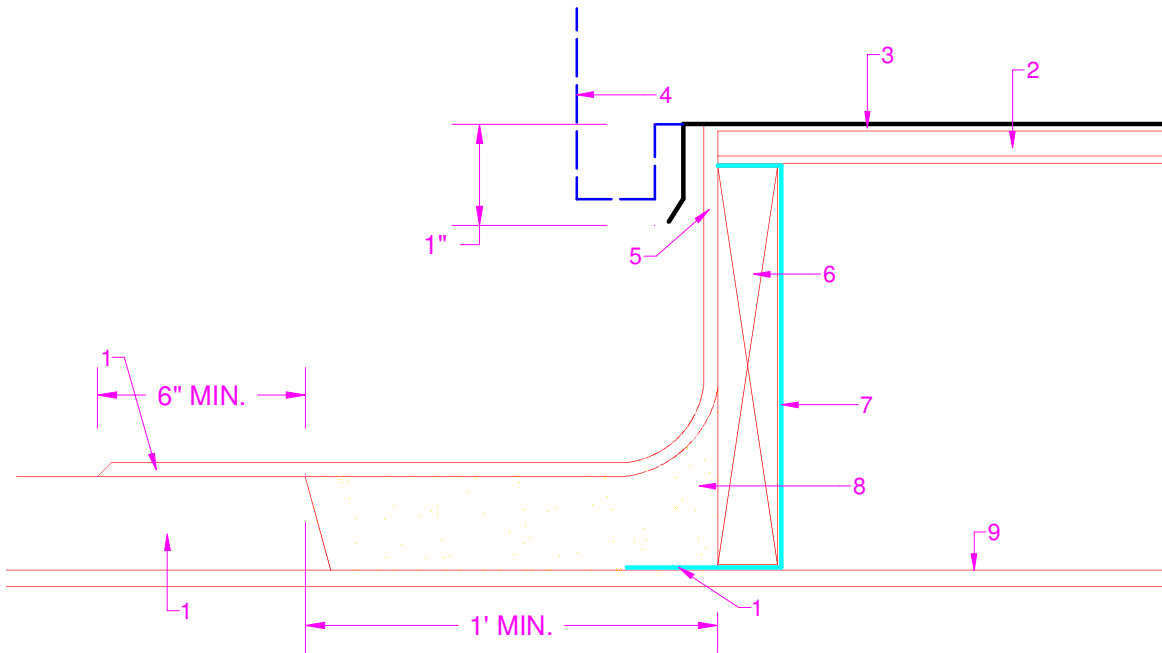
- 1. EXTENDED PROTECTIVE COATING ON EXIST. ROOF
- 2. 5/8" PLYWOOD SCREW TO CURB
- 3. 20 GA. G.I. CURB COVER
- 4. MECHANICAL UNITE
- 5. TECH GUARD COATING SYSTEM
- 6. 2X2 BLOCKING
- 7. MECHANICAL CURB
- 8. NEW FOAM PATCH (TECH GUARD)
- 9. EXISTING PLYWOOD
- 10. SECURE CURB TO ROOF
- 11. EXIST. FOAM ROOF
